NAUGATUCK RIVER BASIN  
SEYMOUR, CONNECTICUT

BLADENS RIVER DAM  
CT 00602

PHASE I INSPECTION REPORT  
NATIONAL DAM INSPECTION PROGRAM

MARCH 1980

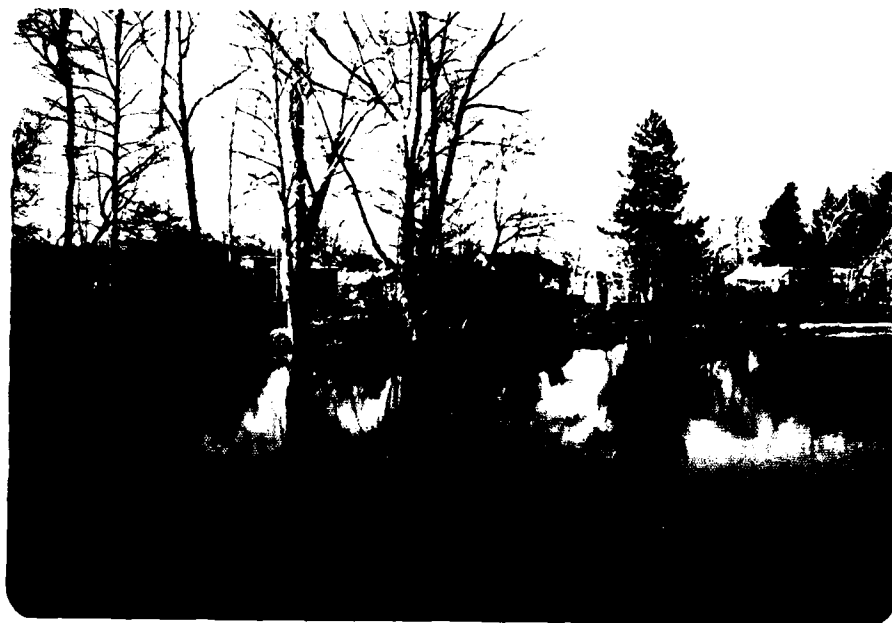
PHOTO NO. 1

UPSTREAM SLOPE OF EARTH EMBANKMENT  
SECTION (LEFT OF PHOTO)

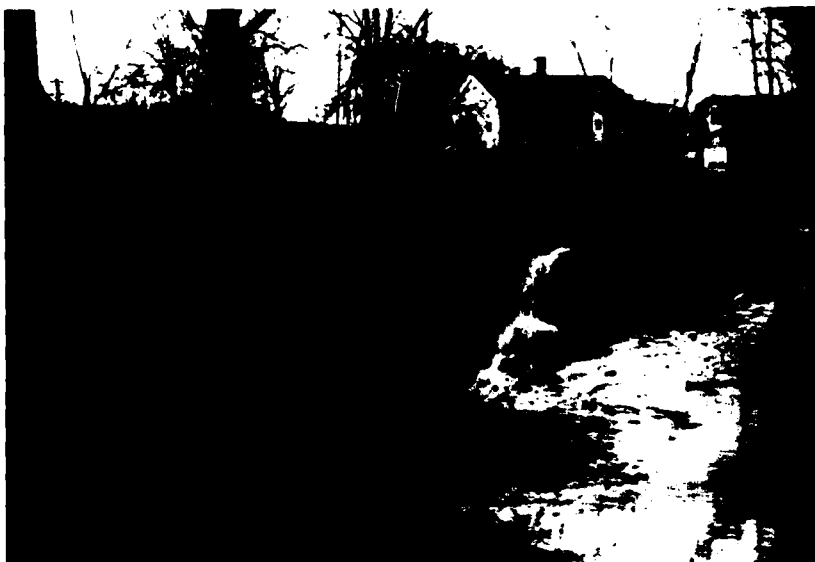
PHOTO NO. 6

The left spillway wall is a dry stone masonry wall, as shown in Photo 7. Past movement of the left spillway wall was indicated by 1) generally open joints between the blocks in the wall, 2) a vertical crack in the stone masonry, Photo 7, 3) tilting of the top of the wall toward the river, Photo 7, and 4) separation between the upstream end of the wall and the edge of the spillway, Photos 5 and 6. Some vegetation was observed growing out of the left

2. Continued movement and tilting of the left spillway wall and erosion below the adjacent upstream wall could result in partial or complete failure of this wall which could produce a dam breach.

UPSTREAM WALL ADJA-  
CENT TO LEFT SPILL-  
WAY WALL AND SPILL-  
WAY CREST. NOTE UN-  
UNDERMINING OF  
UPSTREAM WALL

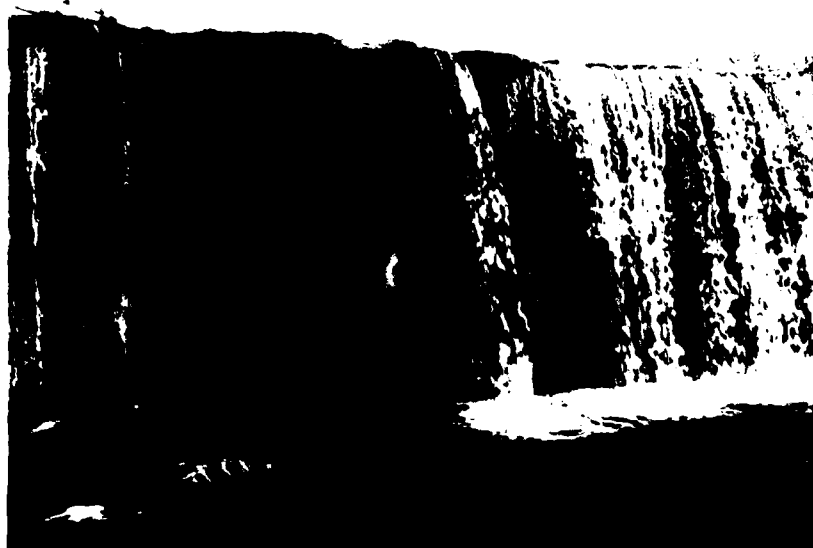
PHOTO NO. 10

The spillway sections of the dam and the auxiliary spillway of the forebay discharge into the natural streambed of the Bladens River. Bedrock outcrops were observed in the streambed at the right side of the dam, as shown in Photo 10.

RIGHT END OF AMBURSEN-TYPE  
BUTTRESS SECTION. NOTE BEDROCK OUTCROP.
